Using safe system approach to analyse road infrastructure causes of road accidents on Yaounde-Bafoussam road

IJASR 2022

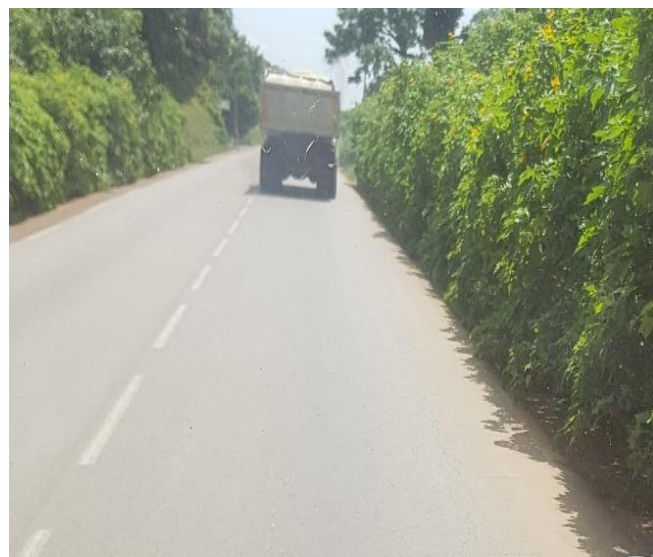
The width of the shoulders is more or less 1.5 m. The presence of the clear zone is rare. Worse still, the shoulders are overgrown with weeds (figure 3). If a truck breaks down in this situation, the road width available for other vehicles is insufficient and safety is severely impaired.

Figure 3. shoulders overgrown by weeds

The concept of the “forgiving roadside design” includes the provision of space by the road side for break down vehicles. In general, this means that, when a driver commits a mistake due to unavoidable circumstances, his or her mistakes will be forgiven by the design concept. Efficiency of side drains must be maintained by regular cleaning to ensure evacuation of rainwater, thus road flooding avoided, and aquaplaning risk reduced.

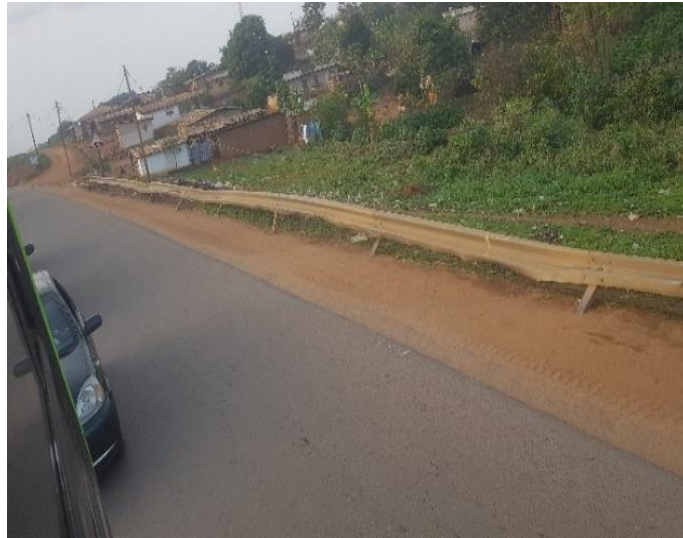
As the road project is being rehabilitated, the damaged guardrails have all been removed on the section of road from Ebebda to the entrance to the town of Bafoussam. New guardrails, in good condition, are therefore being installed on this section. At the level of the T3 road section, nothing has been done so far. thus, the guardrails are in very bad condition (figure 4).

Figure 4. Guardrails in bad condition

The benefits from installing appropriate barrier systems and ensuring that these are adequately maintained can be substantial with the benefits of up to 80 % reductions in severe crash outcomes (Dc, 2021). The state of guardrails is very bad on N4. Because of its importance, it is advisable to always take care to replace those which are broken or deformed after a shock emitted by a vehicle and put each category in the right place. For example, at the level of the various bridges which are after Ndikinimeki (where a bus ran off the bridge at full speed and caused 52 deaths) it is advisable to put there the rigid barriers at least on 10 m after the bridge to limit accident gravity.

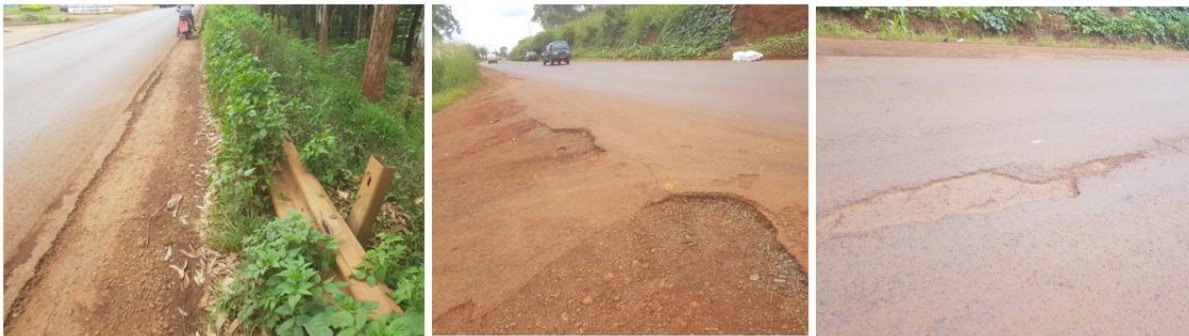
Generally speaking, the study section has a fairly good road surface, thanks to the work carried out on it. However, some sections still need to be improved, as the lack of side drains has led to erosion of part of the shoulders and delamination of the pavement (figure 5).

Figure 5. State of road surface

Regular road maintenance should be performed to guarantee safety of the road user. Also, maintenance costs and time increase with increased degree of defects. Efficiency of side drains has to be maintained by regular cleaning to ensure evacuation of rain water, thus road flooding avoided and aquaplaning risk reduced.

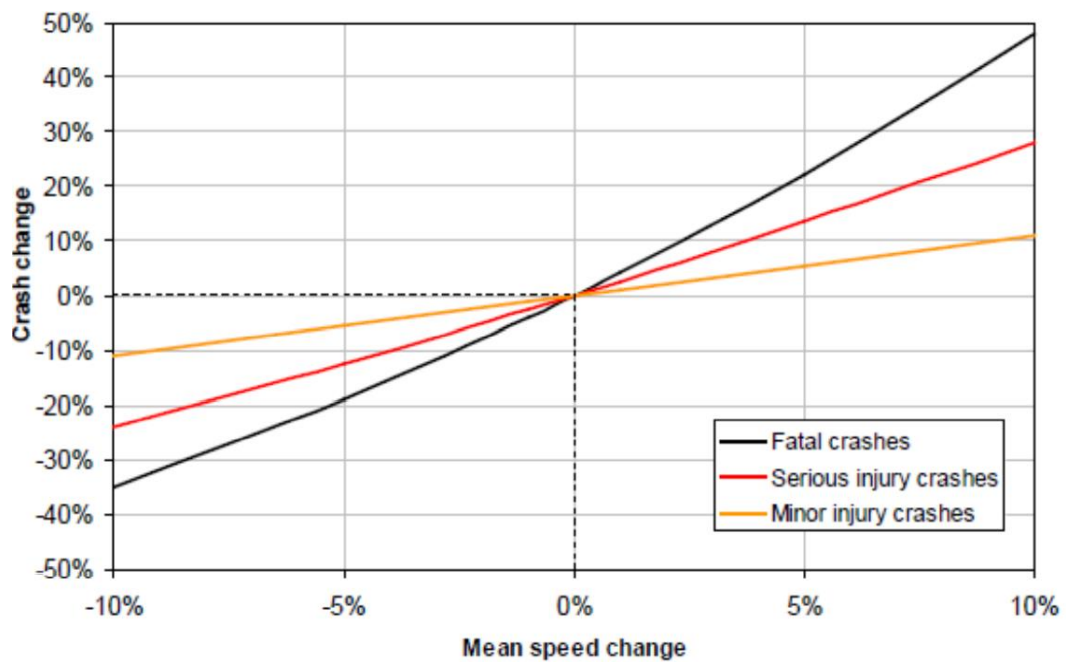
Most accidents as seen are caused by speeding. Speed has an impact on both the likelihood of a crash occurring and the severity of the outcome when crashes occur. Figure 6 provides information on change in speed for rural roads and freeways. This highlights that the more severe crash types (especially fatal crashes) increase most with an increase in speed. Speed is therefore the most important factor to control.

Figure 6. Relationship between change in speed and change in crash risk. (Source: Elvik 2009)

On the national road 4, road infrastructure is mainly composed of 2 lanes without physical separation, so it can not satisfy a very high mobility (speed above 100 km/h) for safety reasons. It would be better to have a maximum speed of 80 km/h and 30km/h where pedestrians are present, to ensure the right balance between mobility and safety.
